Producing Hydrogen: Learnings from CUTE

Holger Grubel, Vattenfall Europe Hamburg AG

Klaus Stolzenburg, PLANET GbR

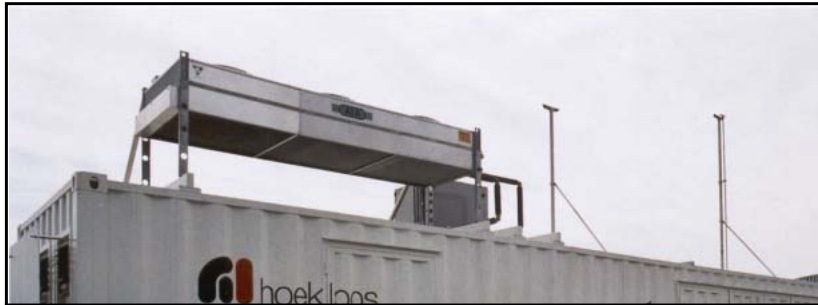
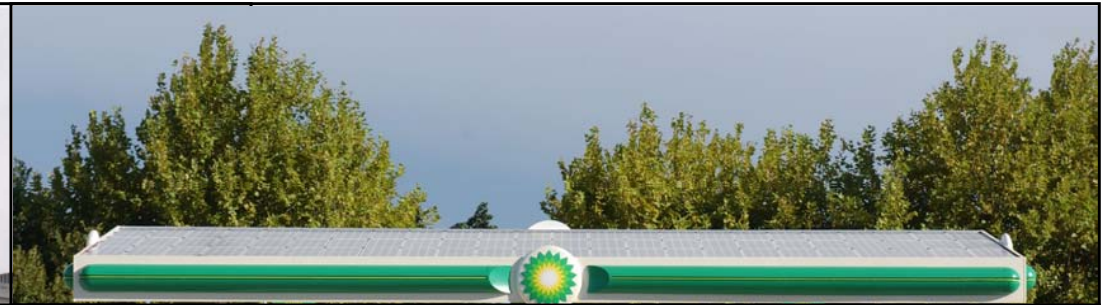
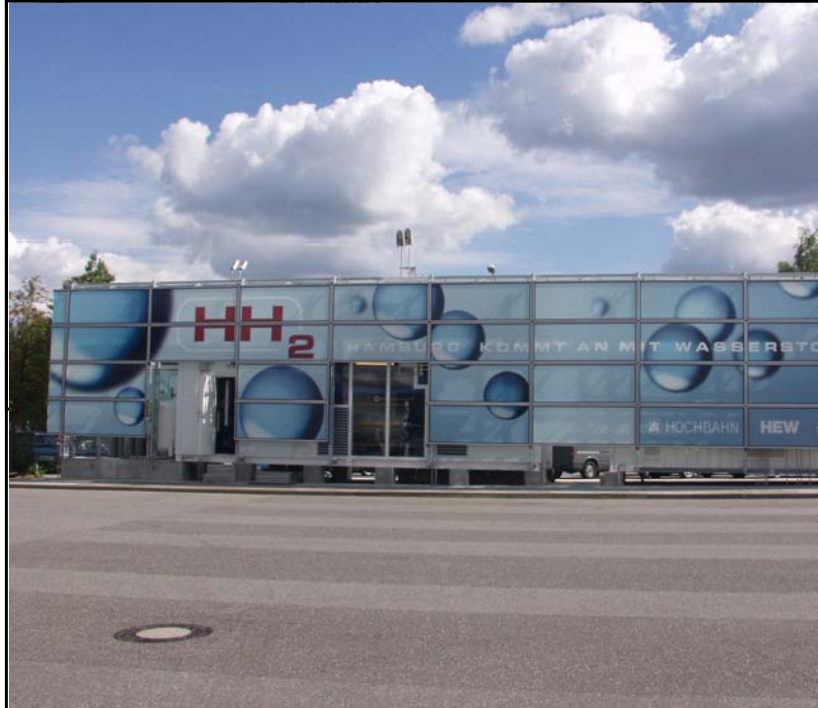
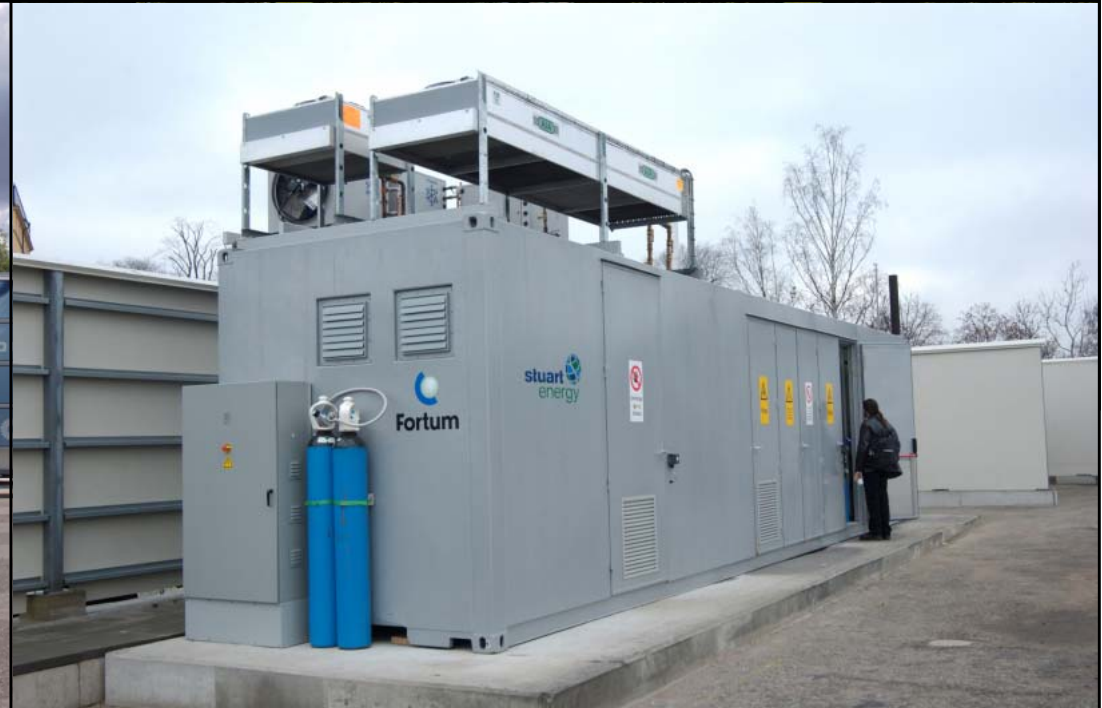
3. Electrolysers in Amsterdam, Barcelona, Hamburg and Stockholm

Amsterdam	Barcelona	Hamburg	Stockholm
Rated production [Nm ³ /h]	15 – 60	15 - 60	30 – 60	15 - 60
Installed power [kW]	400	400	390	400
Power source	green	grid mix (+ PV on site)	green	green
Rated energy demand (stack+pumps) [kWh/Nm ³]	4,8 +/- 0,1			
Resulting efficiency	63%			
External supply	no	backup	(backup)	no

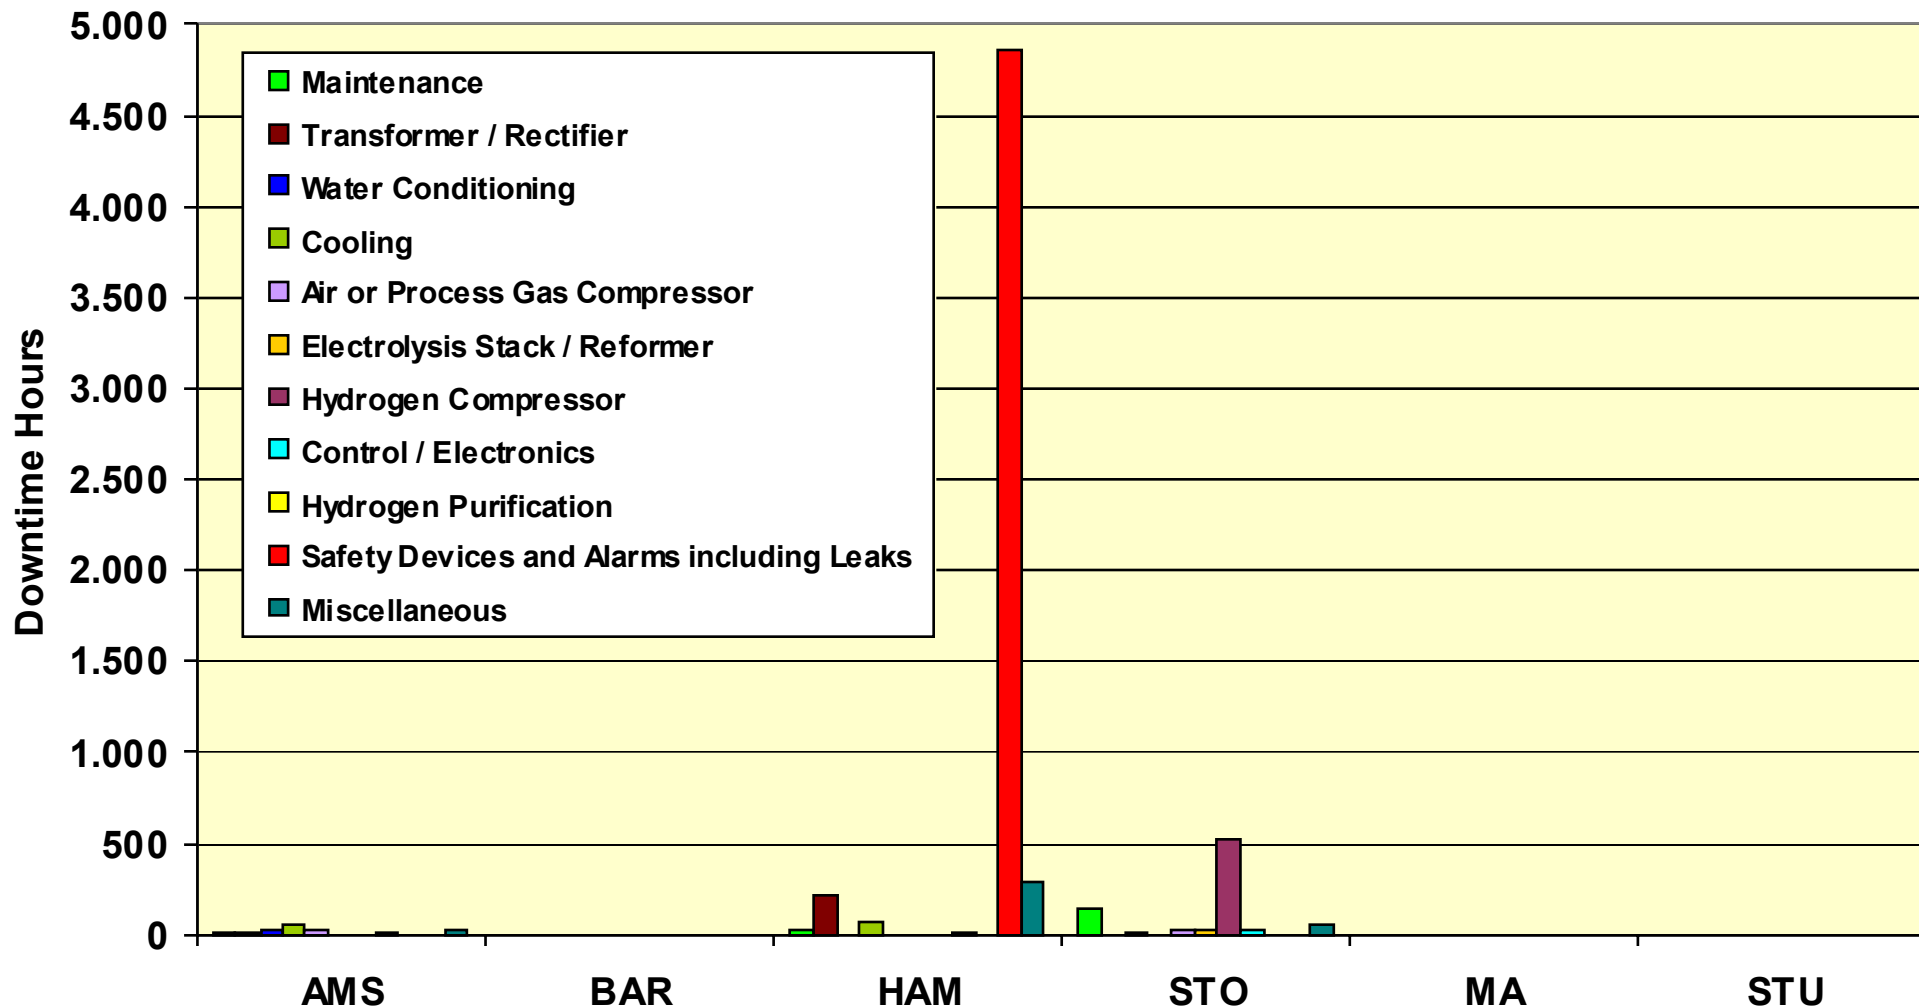
3. Performance Indicators: Causes for Downtime

Explanation Hamburg / Leakage

- **Crack corrosion caused leakages in lye loop (30 % KOH, ~80°C, 15 bar, oxygen saturated)**
- **Pipe material (AISI 316L) had to be exchanged**
- **New material (Duplex SAF 2205) may not be welded under these conditions**
- **Pipes < DN 20 connected through fittings type “Gyrolock”**
- **Larger pipes have to be nickel coated**

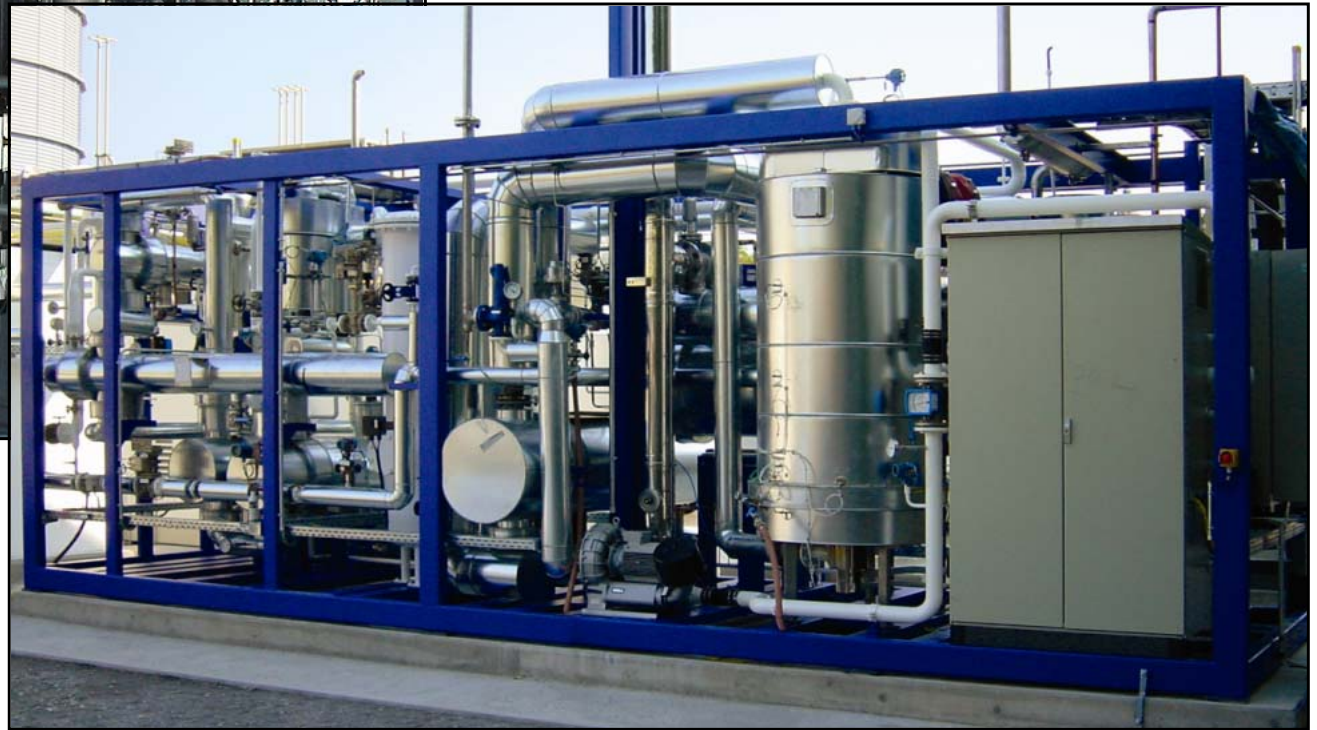
4. Steam Reformer in Madrid and Stuttgart

Madrid	Stuttgart
Rated production	[Nm ³ /h]	30 – 50	50 – 100
Installed power	[kW]	45	89
Power source		grid mix	grid mix
Rated thermal energy demand	[kWh/Nm ³]	4,86	4,65
Resulting thermal efficiency		62%	65%
External supply		regular	backup

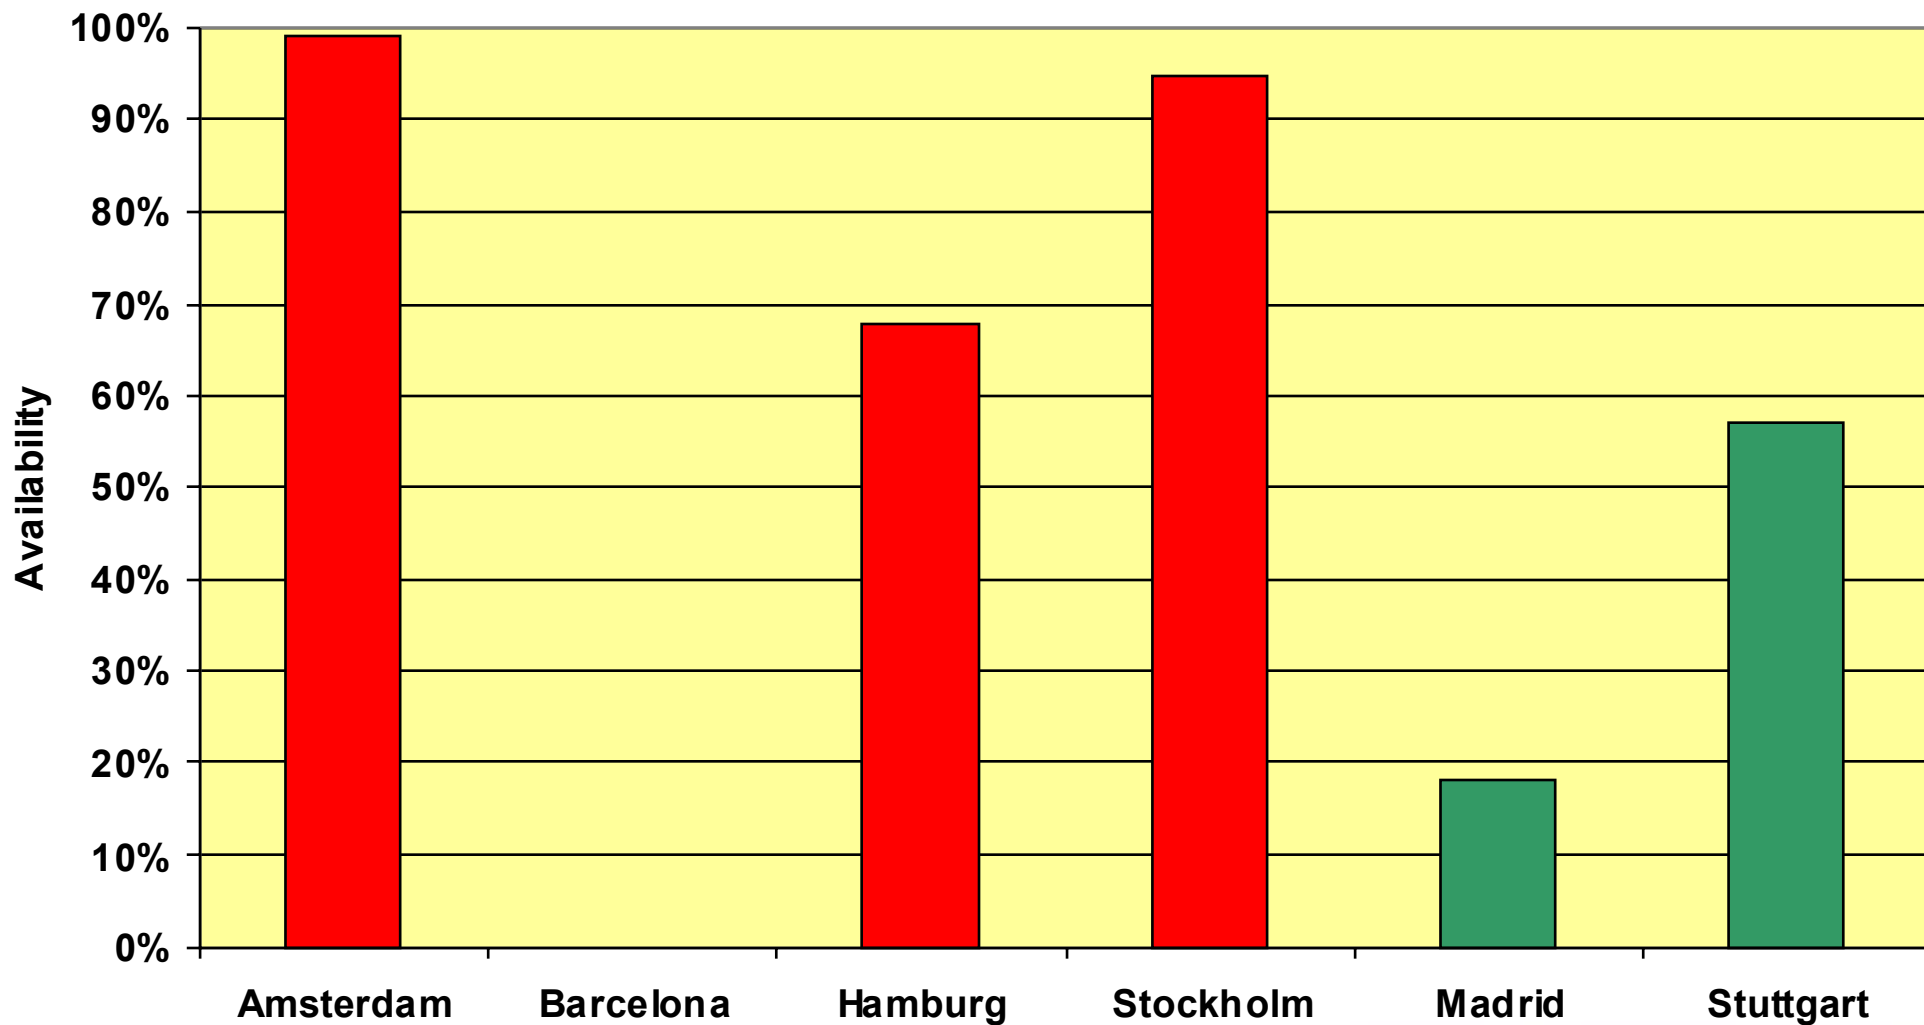
4. Performance Indicators: Availability Production Units

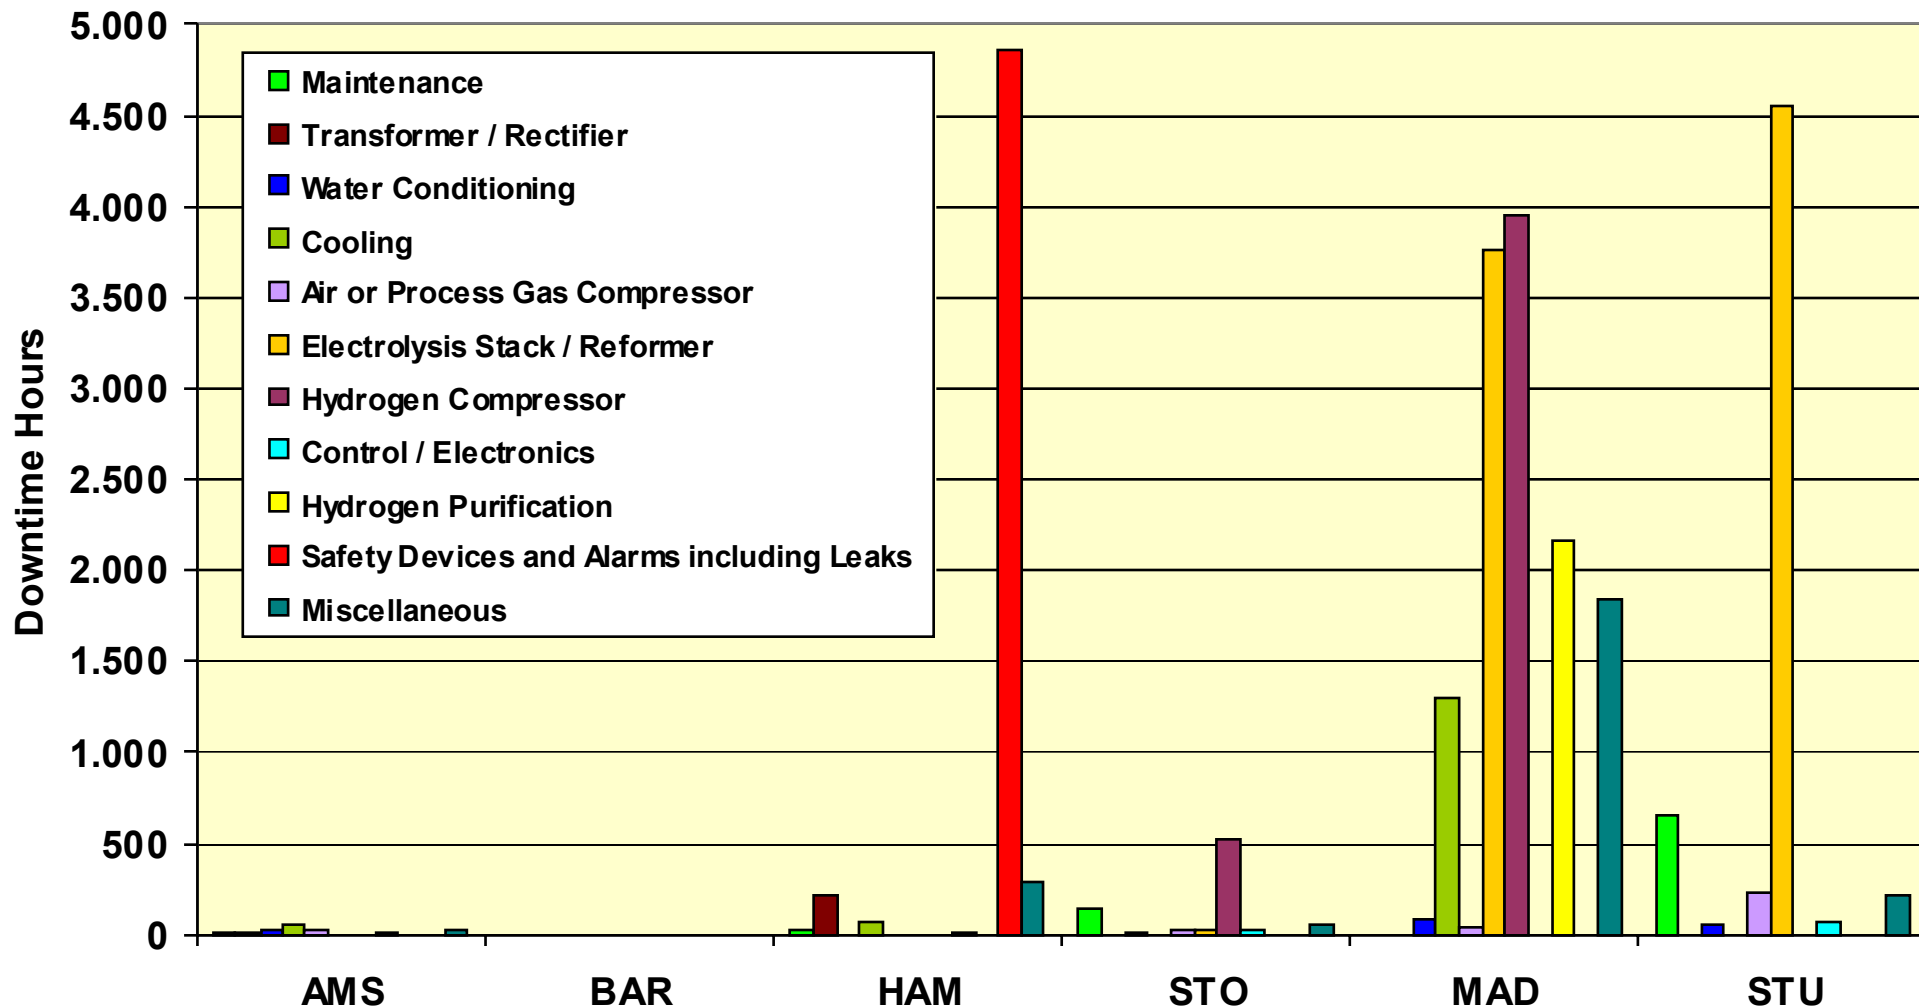
4. Learnings from Operation: Causes for Downtime

- **Stuttgart: single problem**
higher reformer temperatures than anticipated
→ material issues (cracks, construction element damaged)

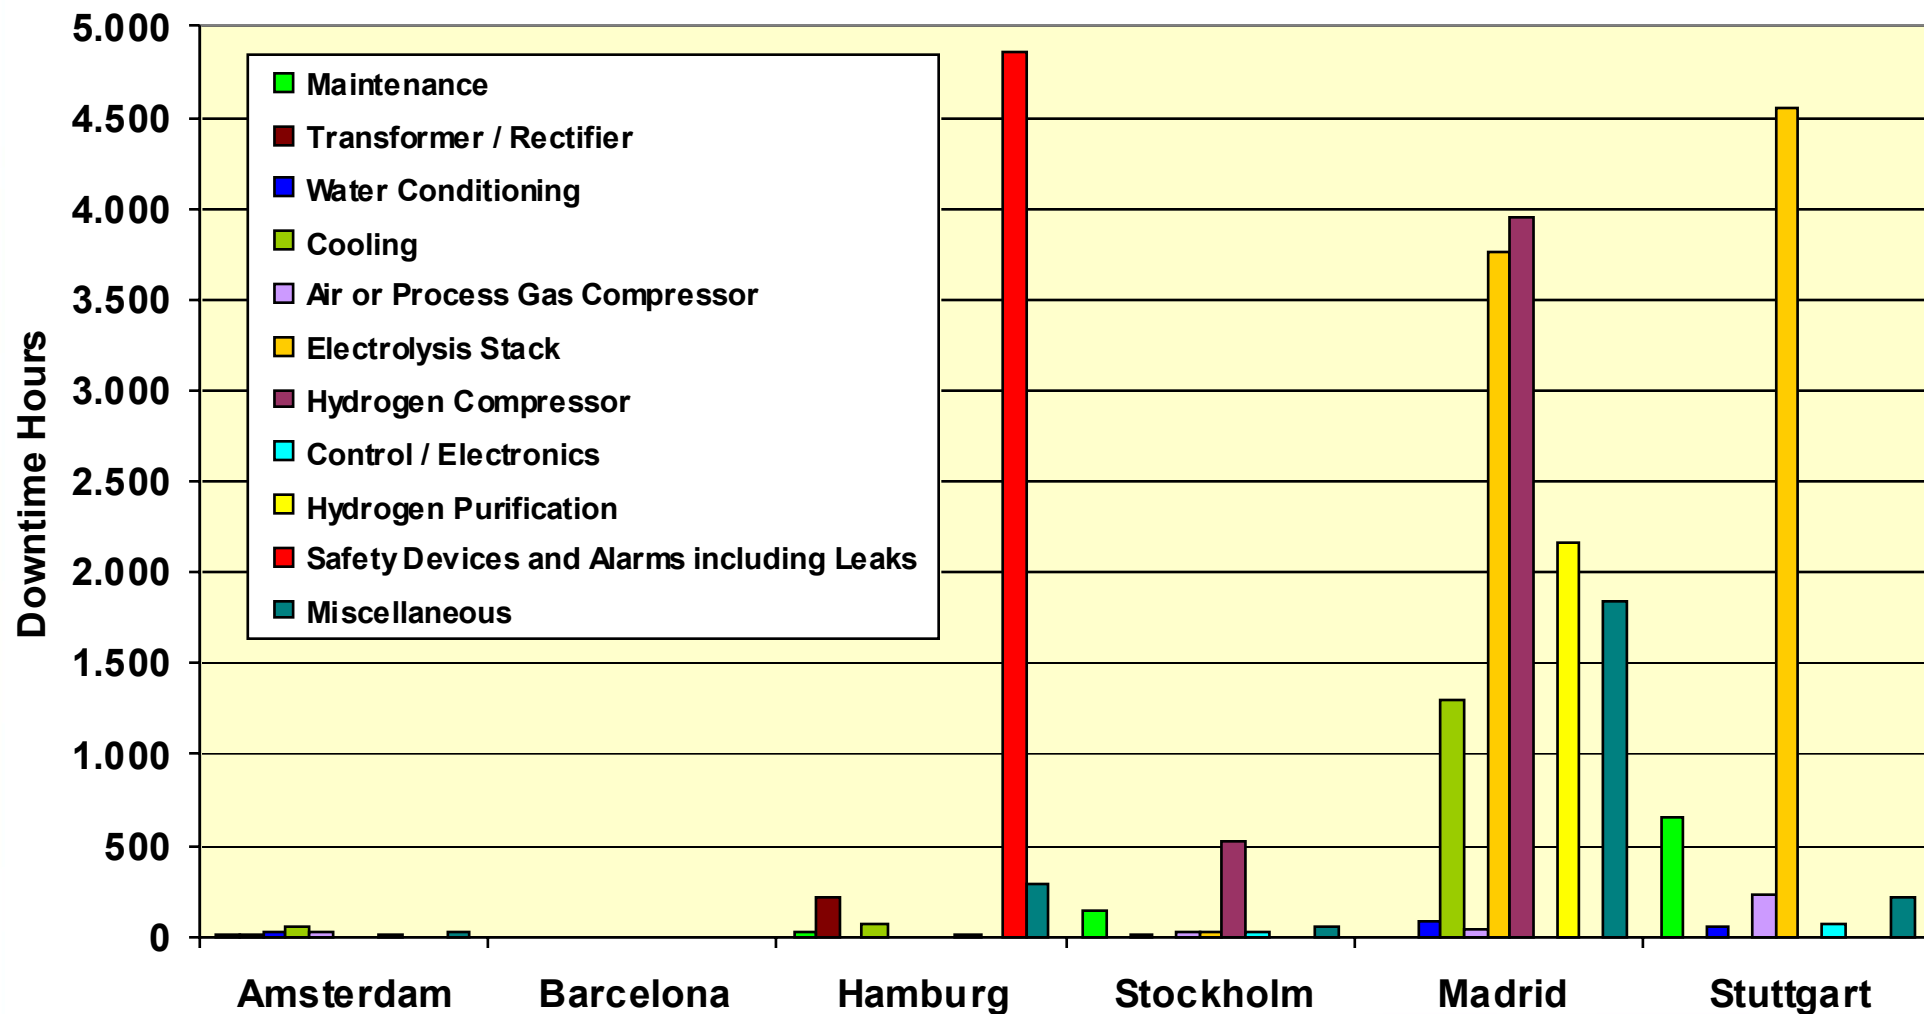
4. Learnings from Operation: Causes for Downtime

- **Stuttgart: single problem**
higher reformer temperatures than anticipated
→ material issues (cracks, construction element damaged)
- **Madrid: series of different issues**
with reformer, compressors, cooling, purification, ...
- **Start-up and shut-down cycles complex**
→ operate continuously at the cost of venting surplus hydrogen
- **Part-load operation reduces thermal efficiency**
Madrid: 62% rated → 39%
Stuttgart: 65% rated → 42%

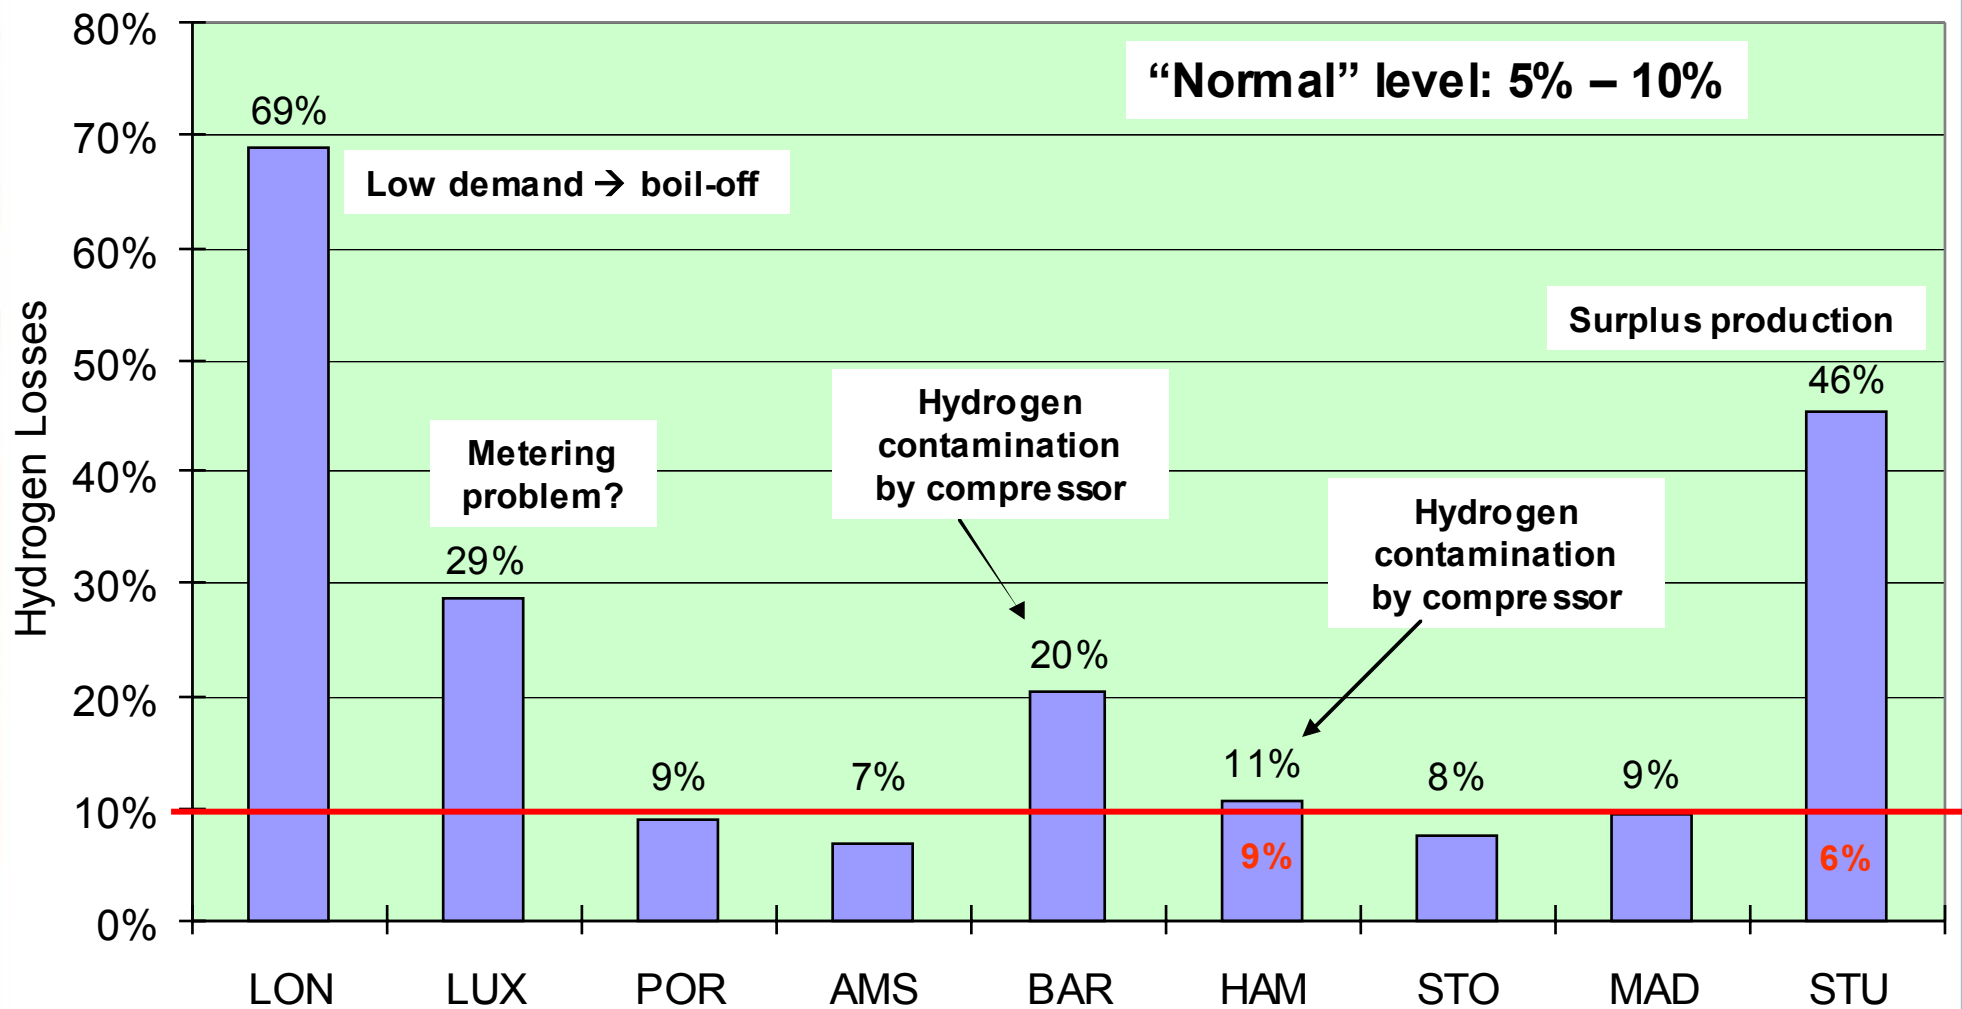
5. Further Learnings from Operation: Hydrogen Losses
